# IMPORTANT - STOP USE AND INSPECT - POTENTIAL CABLE FRAYING / BIRD-CAGING - HALO & EDGE CABLE SELF-RETRACTING LIFELINES (SRLs)

This notice applies only to the Guardian SRL part #s listed herein, and only for products manufactured from January 1st, 2015 through March, 2017. A small number of these units have shown an increased potential for cable fraying at the swage and/or cable bird-caging. If these conditions are present, Guardian will repair affected units at no charge. This notice does not apply to new/unused units.

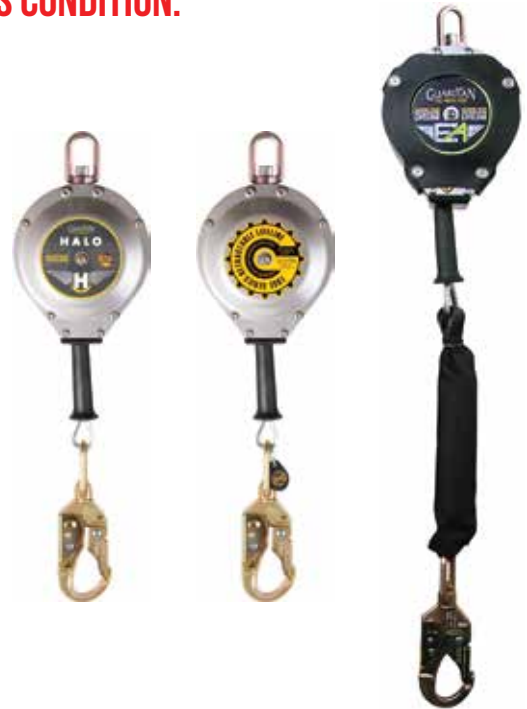
- #10910 (20' 3/16" Galvanized Cable SRL)
- #10912 (25' 3/16" Galvanized Cable SRL)
- #10915 (30' 3/16" Galvanized Cable SRL)
- #10920 (20' 3/16" Galvanized Cable SRL-LE)
- #10922 (25' 3/16" Galvanized Cable SRL-LE)
- #10925 (30' 3/16" Galvanized Cable SRL-LE)
- Any custom part (length: 30' or less) that uses an Edge or Halo Cable SRL as its base model.
